# Inspection Report

**Property Address:**  
1234 1st Second St  
Southbay CA 90732

**Accord Property Inspection LLC**

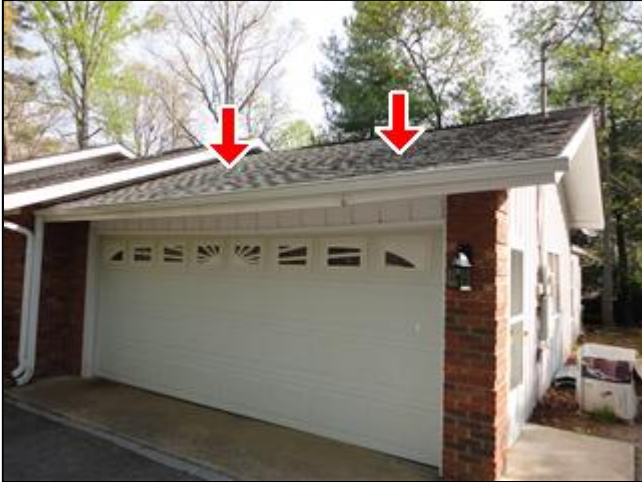
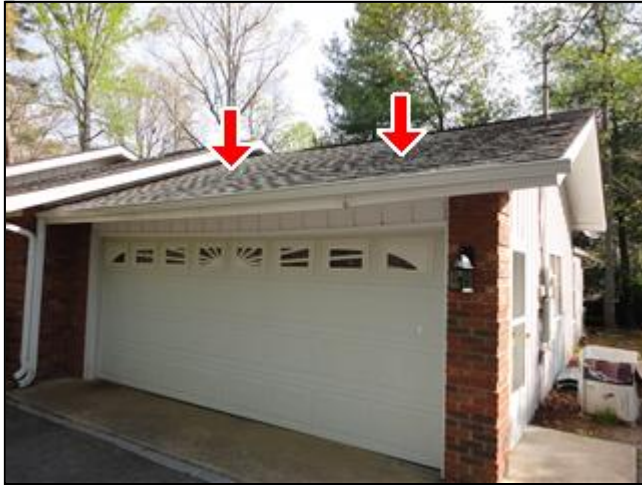
1.0 Item 1(Picture)

**1.0 (2)** The roof covering was installed improperly above garage. Roof sheathing needs to be replaced in this area. This will involve some shingle replacement. A qualified contractor should inspect and repair as needed.

(2) The roof covering was installed improperly above garage. Roof sheathing needs to be replaced in this area. This will involve some shingle replacement. A qualified contractor should inspect and repair as needed.

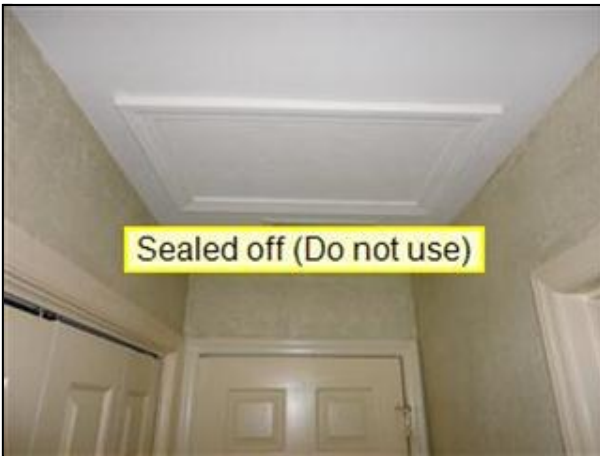
1.5 Item 1(Picture)

**1.5** No longer an attic access. Use the pull down stairs at garage.

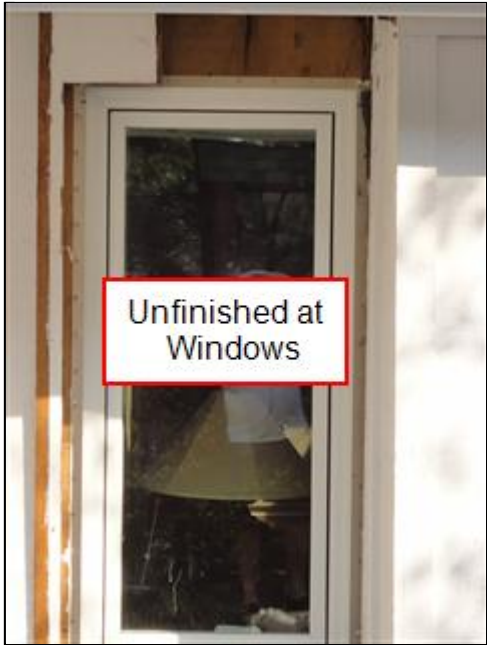
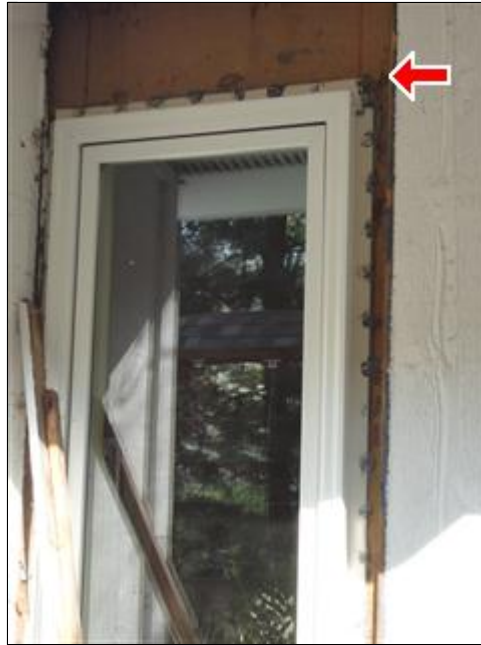
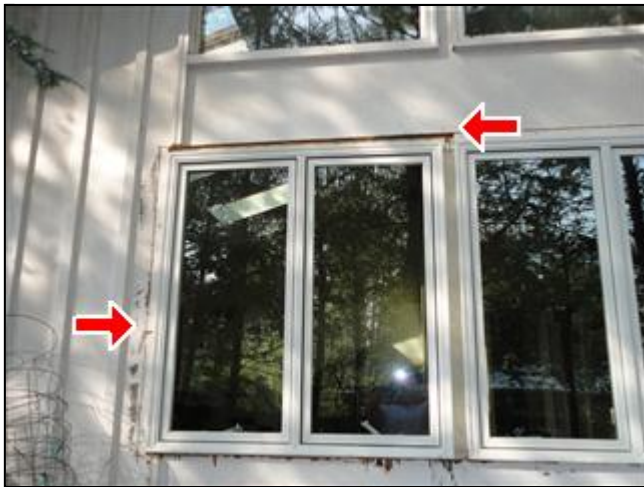
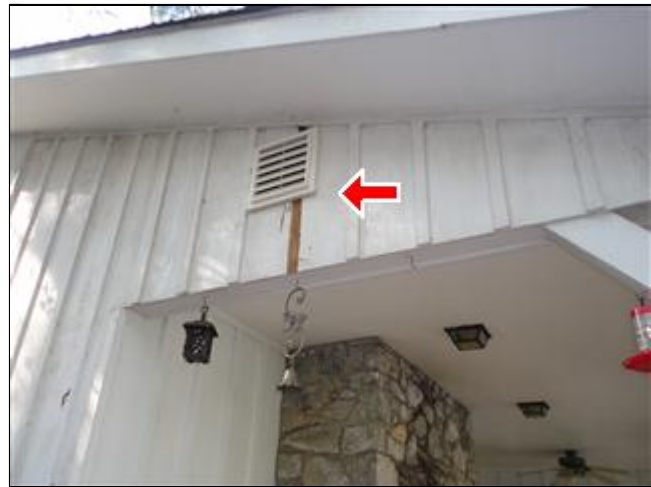
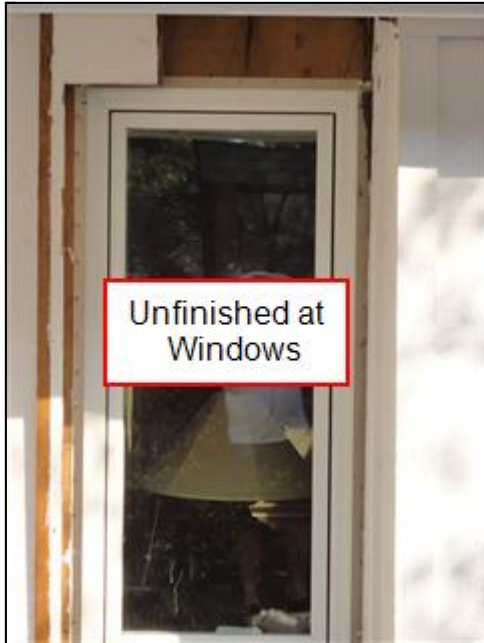
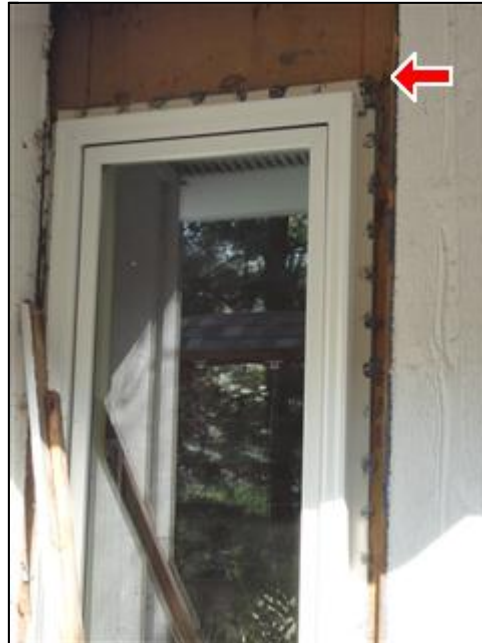
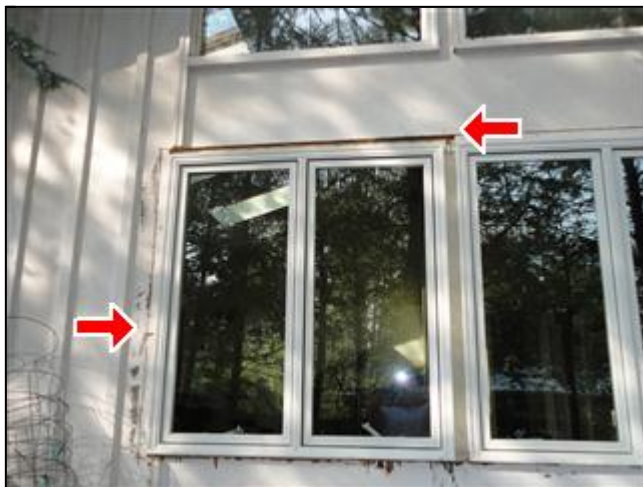
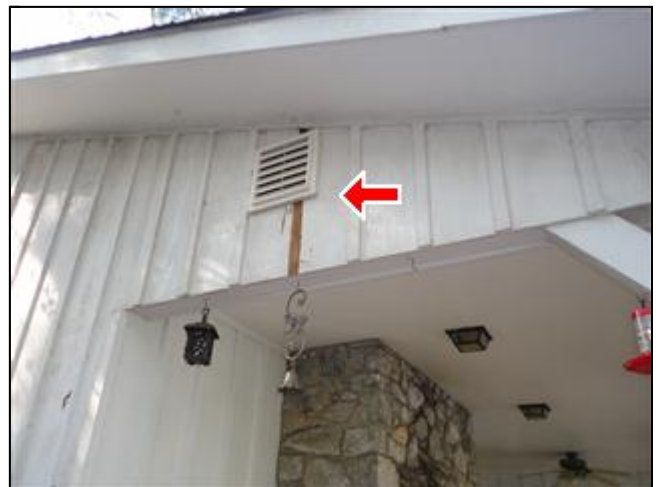
2.0 Item 1(Picture)

**2.0** The Wood siding at the right side (facing front) and rear of home is missing or incomplete at time of inspection around new premium windows that have recently been installed. I did not inspect the installation of siding at this location. A qualified contractor should inspect and repair as needed. The siding will need prep and paint.

The Wood siding at the right side (facing front) and rear of home is missing or incomplete at time of inspection around new premium windows that have recently been installed. I did not inspect the installation of siding at this location. A qualified contractor should inspect and repair as needed. The siding will need prep and paint.

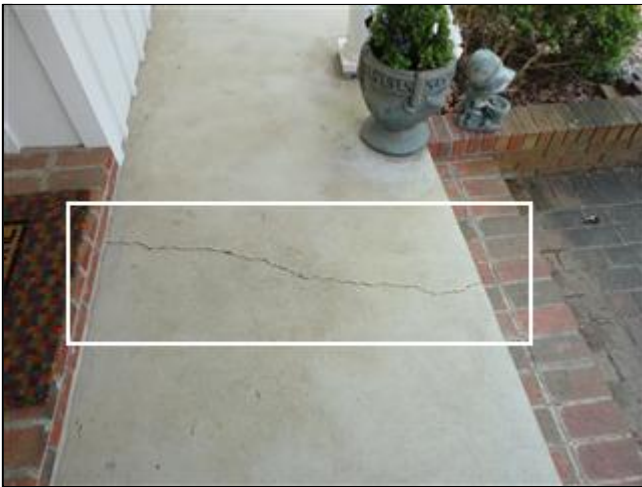
2.4 Item 1(Picture)

2.4 (2) Concrete is cracked at front entrance of home. Appears to only affect the slab itself and is more cosmetic.

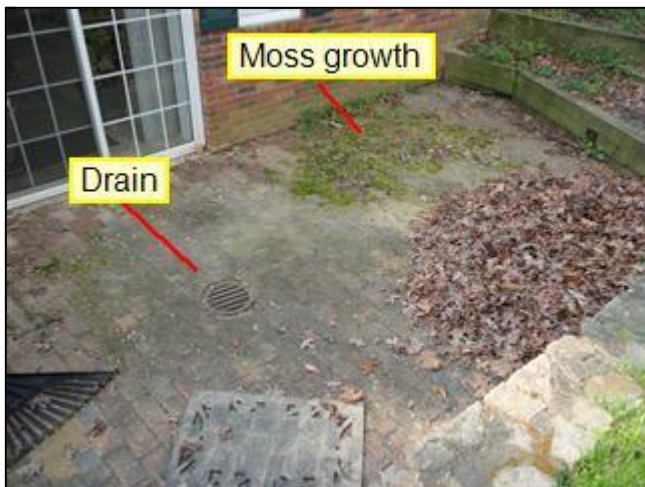
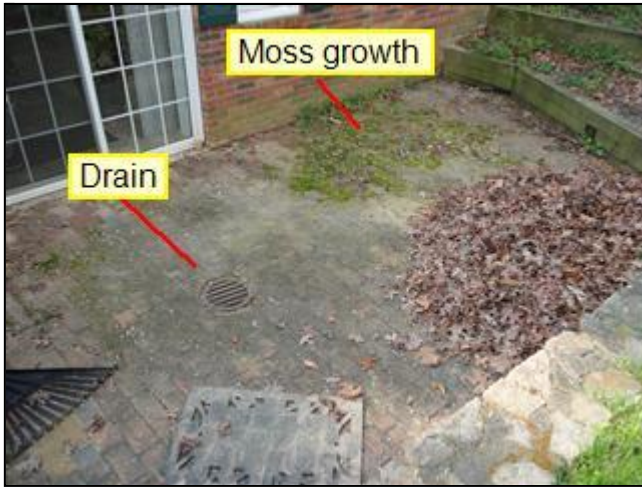
2.4 Item 2(Picture)

🔧 2.4 (3) The brick floor on the patio at the left side (facing front) has deteriorated mortar or grout, and is loose and uneven in areas. Water can cause further deterioration if not repaired and sealed properly. A qualified contractor should inspect and repair as needed.

- (1) Possible water run-off from the street into driveway during rain. I am unable to determine the frequency or amount.
- (3) The brick floor on the patio at the left side (facing front) has deteriorated mortar or grout, and is loose and uneven in areas. Water can cause further deterioration if not repaired and sealed properly. A qualified contractor should inspect and repair as needed.

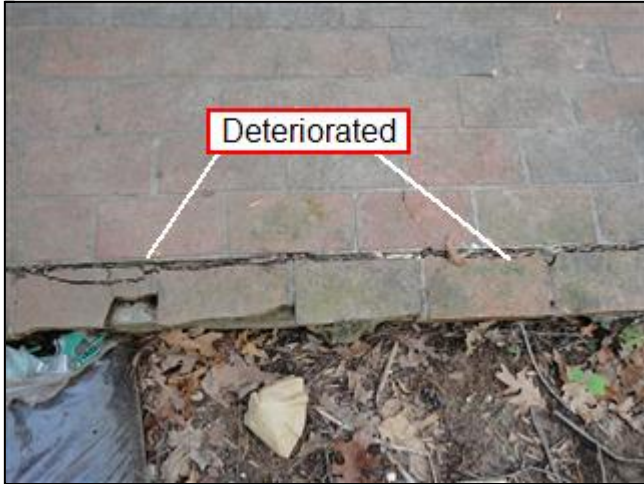
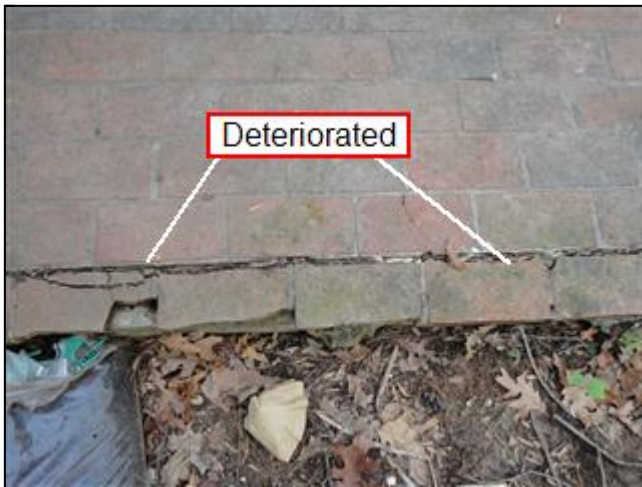
2.4 Item 3(Picture)

**2.4 (4)** The brick floor on the patio at the rear of home is old and deteriorated. A general replacement is likely. A qualified contractor should inspect and repair as needed.

- (4) The brick floor on the patio at the rear of home is old and deteriorated. A general replacement is likely. A qualified contractor should inspect and repair as needed.

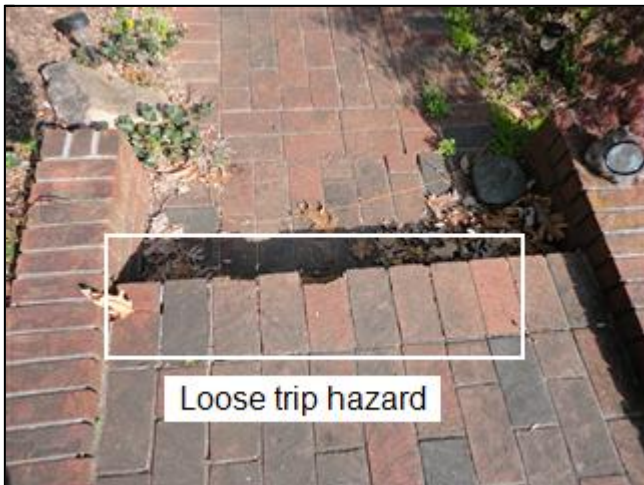
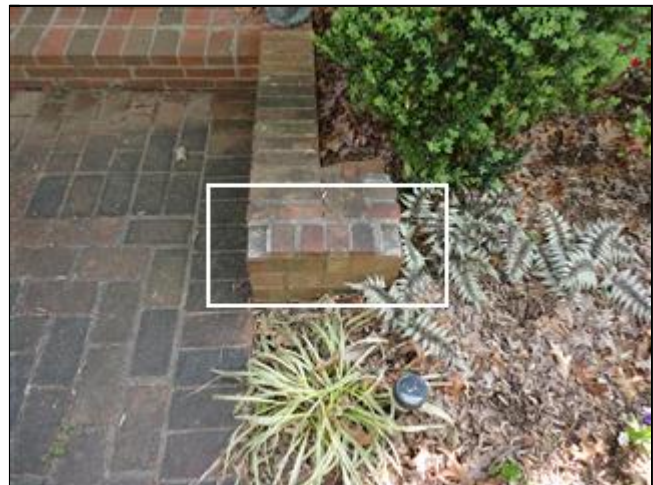
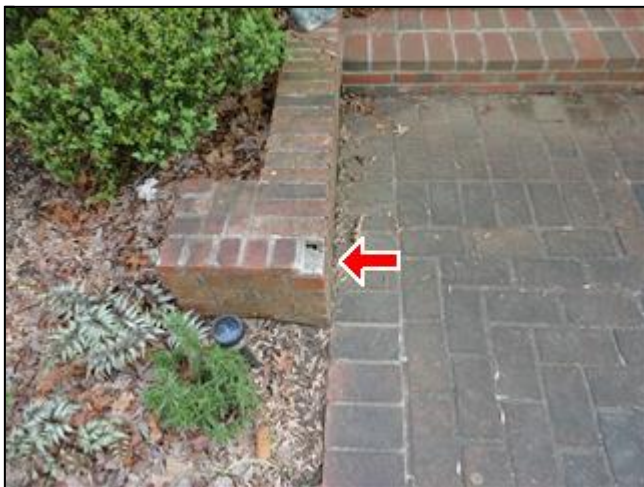
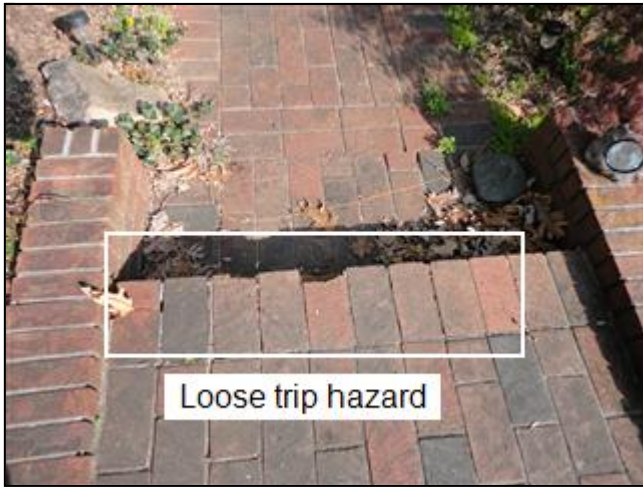
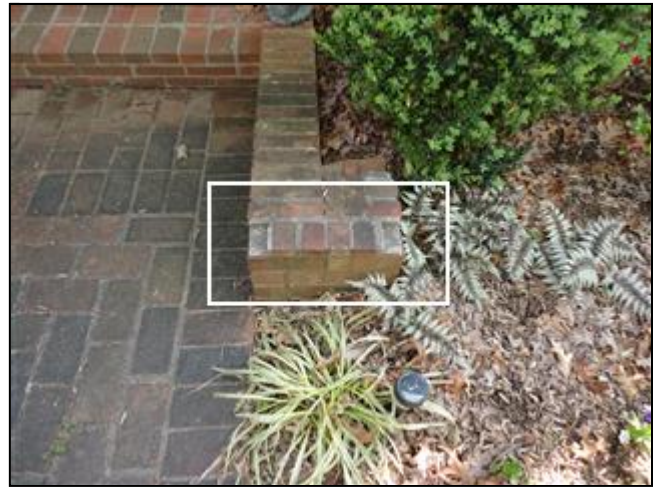
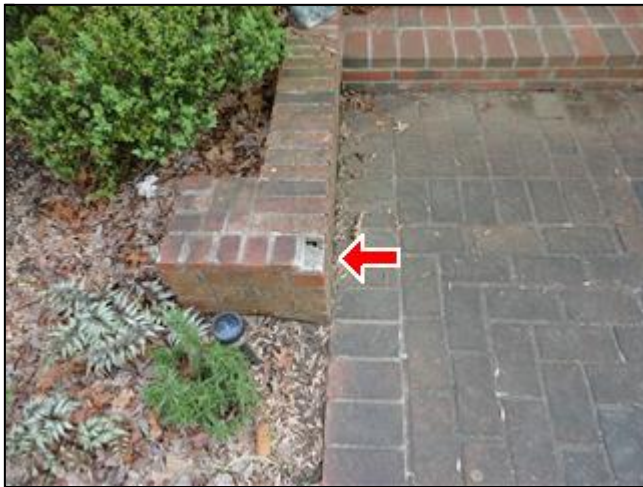
2.4 Item 4(Picture)

**2.4 (5)** The brick walkway at the front of home are deteriorated in areas. A general replacement is likely. A qualified contractor should inspect and repair as needed to eliminate the tripping hazard.

- (5) The brick walkway at the front of home are deteriorated in areas. A general replacement is likely. A qualified contractor should inspect and repair as needed to eliminate the tripping hazard.

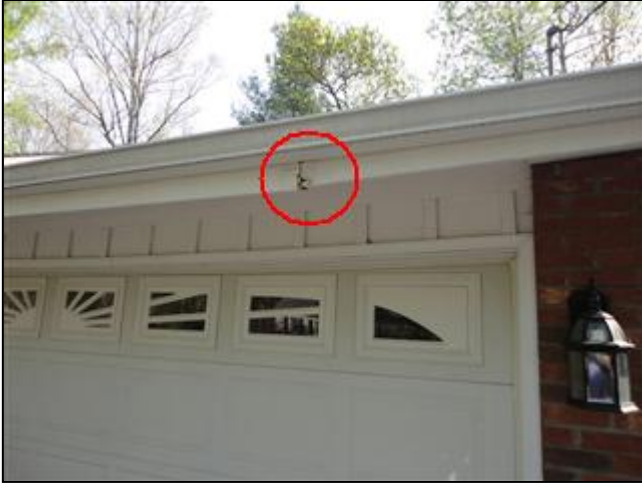
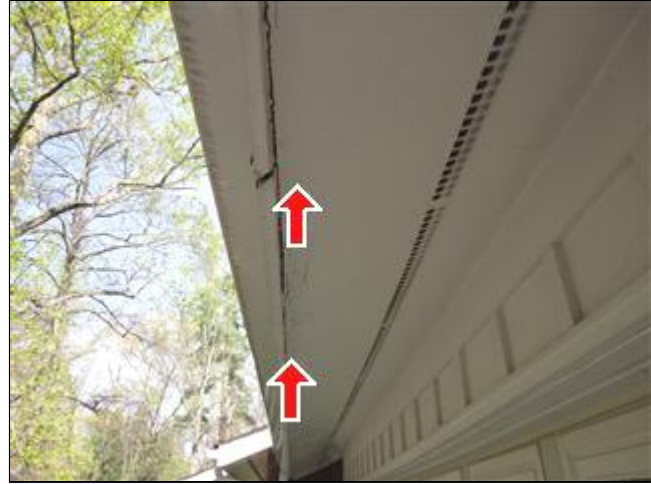
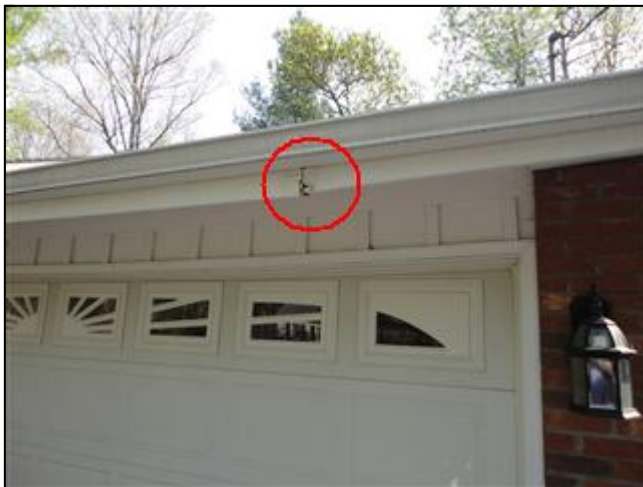
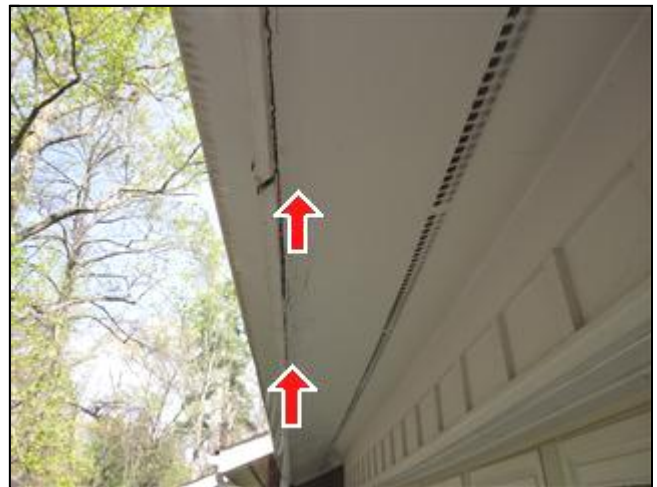
2.5 Item 1(Picture)

**2.5 (1)** The wood fascia and soffit panels at eave on the front of home above garage are deteriorated and show signs of possible dry-rot. This condition left unattended could spread causing further damage. Repairs are needed to roof covering as well. A qualified contractor should repair as needed.

- (1) The wood fascia and soffit panels at eave on the front of home above garage are deteriorated and show signs of possible dry-rot. This condition left unattended to could spread causing further damage. Repairs are needed to roof covering as well. A qualified contractor should repair as needed.

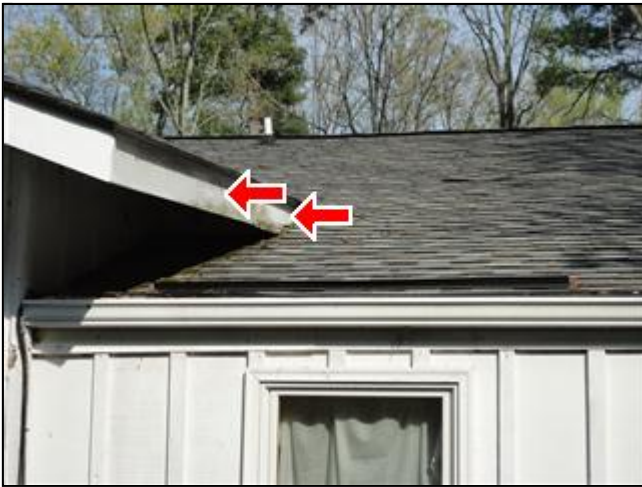
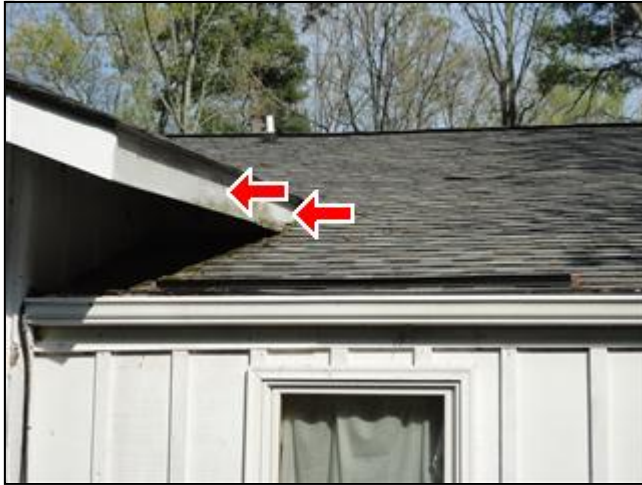
2.5 Item 3(Picture)

**2.5 (2)** The wood fascia at eave on the right side (facing front) is deteriorated. This is a small repair. A qualified contractor should inspect and repair as needed.

- 🔧 (2) The wood fascia at eave on the right side (facing front) is deteriorated. This is a small repair. A qualified contractor should inspect and repair as needed.

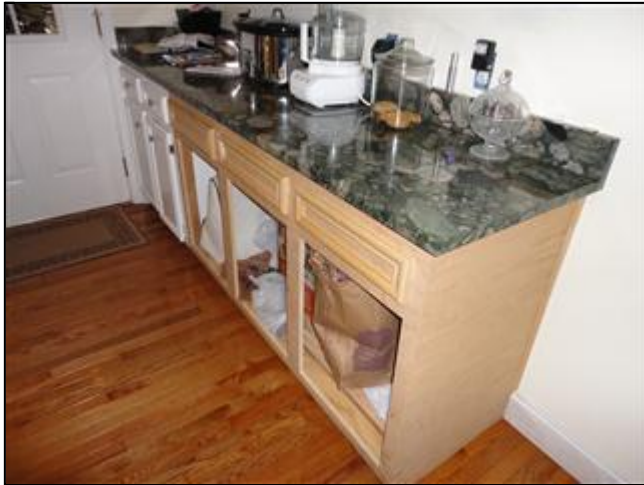
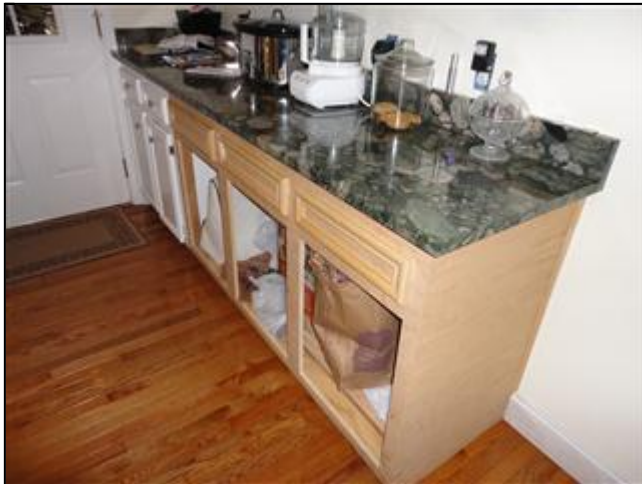
4.5 Item 1(Picture)

**4.5** Base Cabinetry and trim at wall cabinet are **missing doors and sealer** at kitchen.

- 🔧 Base Cabinetry and trim at wall cabinet are missing doors and sealer at kitchen.

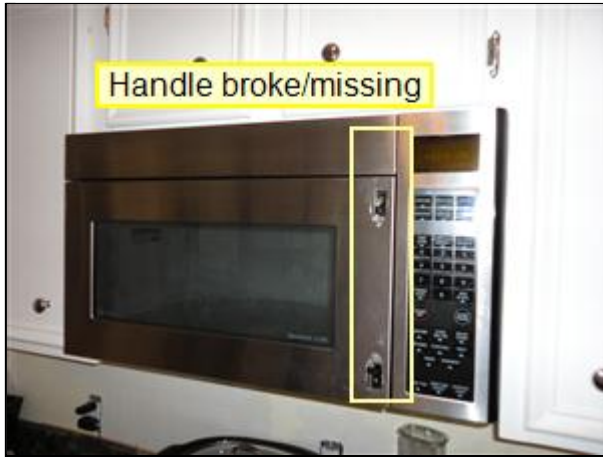
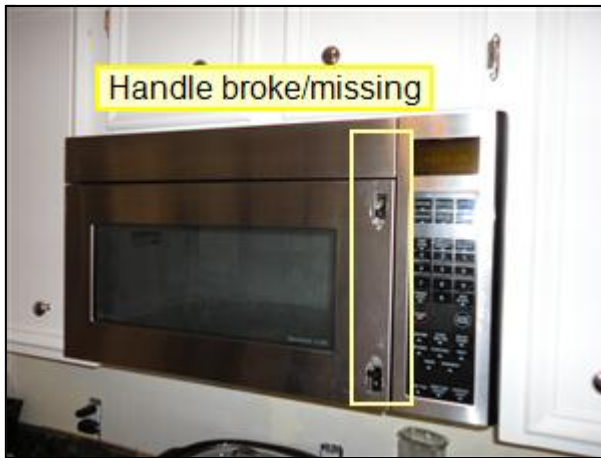
4.14 Item 1(Picture)

**4.14** The microwave door handle is broken. I recommend repair as needed.

- 🔧 The microwave door handle is broken. I recommend repair as needed.

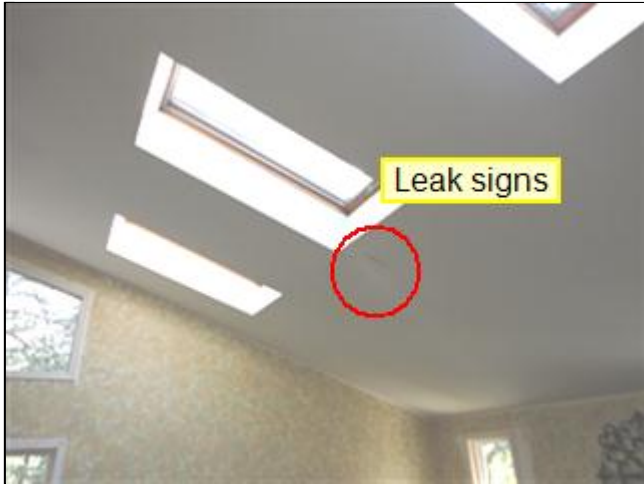
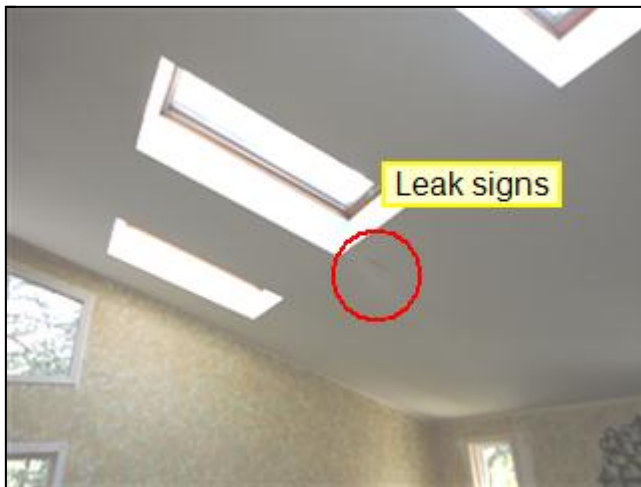
5.0 Item 1(Picture)

**5.0 (1)** The Sheetrock on the ceiling reveals a water stain indicating a leak did or still exists at the Den. Repairs are needed. A qualified contractor should inspect to find source of leak and repair as needed which will prevent further damage(See Roof Coverings).

- (1) The Sheetrock on the ceiling reveals a water stain indicating a leak did or still exists at the Den. Repairs are needed. A qualified contractor should inspect to find source of leak and repair as needed which will prevent further damage(See Roof Coverings).

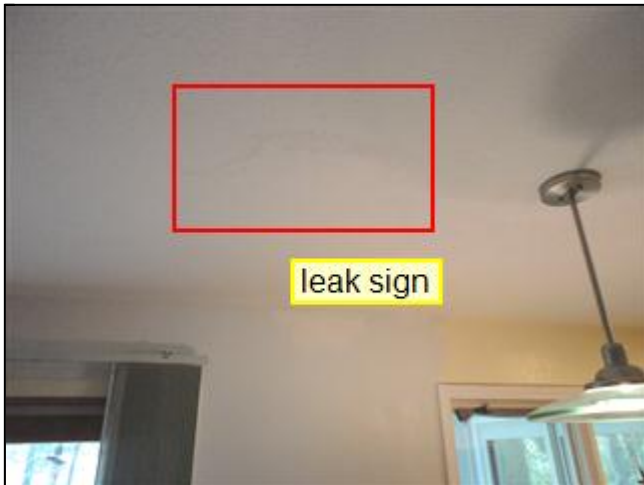
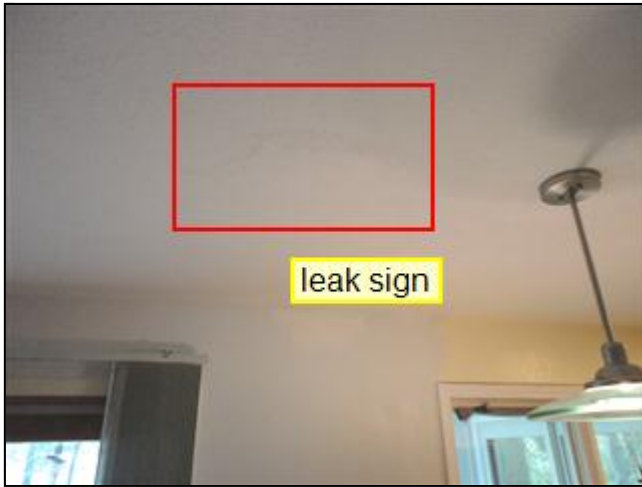
5.0 Item 2(Picture)

**5.0 (2)** The Drywall on the ceiling reveals a water stain indicating a leak did or still exists at the Dining Room. Repairs are needed. A qualified contractor should inspect to determine source of leak and repair as needed. Area in Attic is dry at present so I cannot determine source of leak.

- (2) The Drywall on the ceiling reveals a water stain indicating a leak did or still exists at the Dining Room. Repairs are needed. A qualified contractor should inspect to determine source of leak and repair as needed. Area in Attic is dry at present so I cannot determine source of leak.

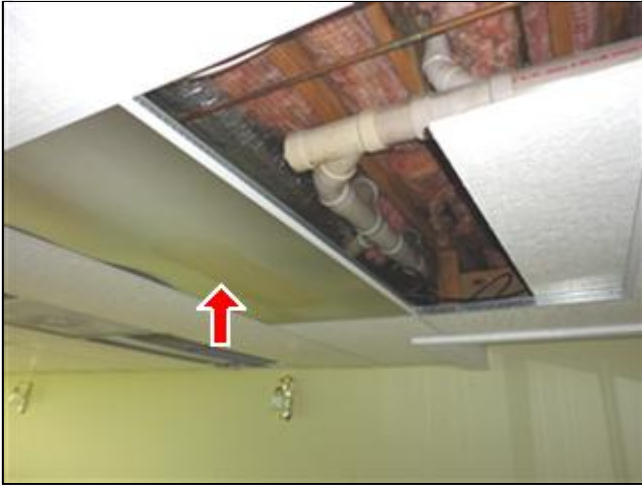
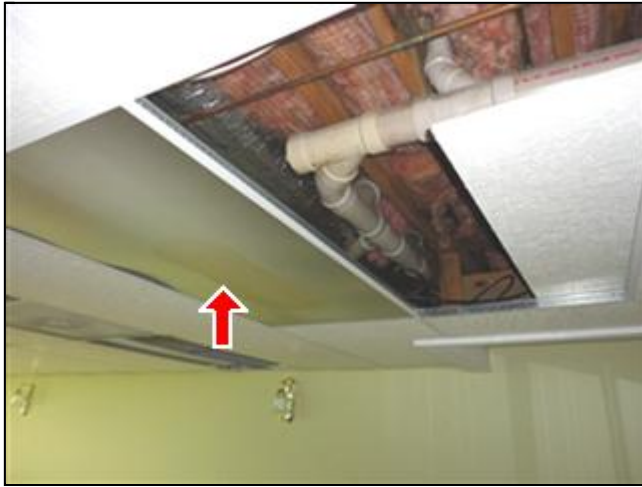
5.0 Item 3(Picture)

**5.0 (3)** Water stain on ceiling panel lower level indicates probable plumbing leak.

- (3) Water stain on ceiling panel lower level indicates probable plumbing leak.

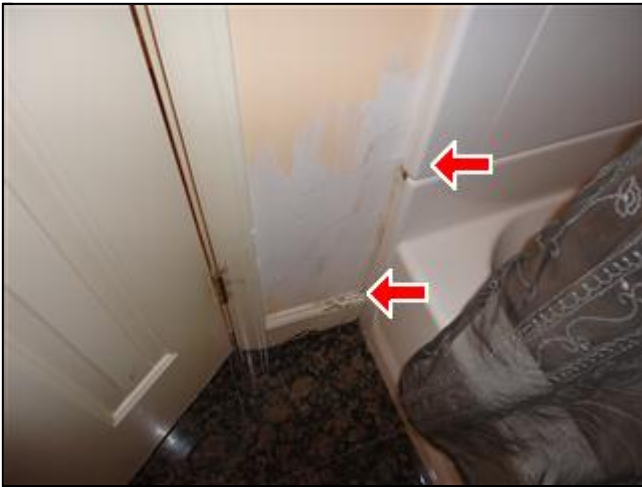
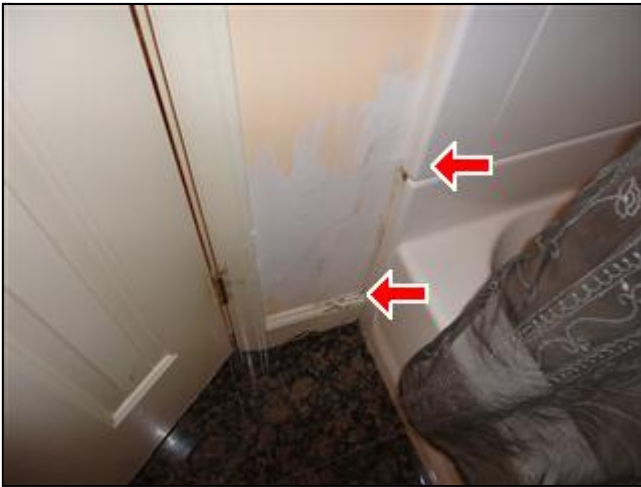
5.1 Item 1(Picture)

**5.1 (2)** The Wall at the bathtub is deteriorated and needs repair or replacement. The wall board and framing may need repair (not visible). I recommend repair or replace using a qualified contractor, without opening wall and exposing framing I am unable to determine extent of damage.

- (1) Unfinished around windows in kitchen, and Den.
- (2) The Wall at the bathtub is deteriorated and needs repair or replacement. The wall board and framing may need repair (not visible). I recommend repair or replace using a qualified contractor, without opening wall and exposing framing I am unable to determine extent of damage.

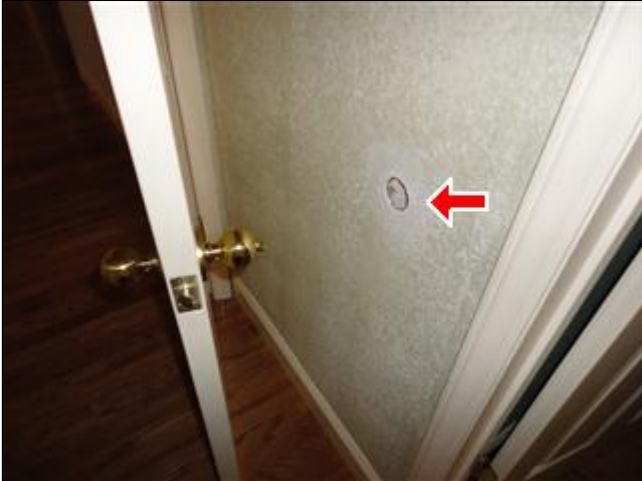
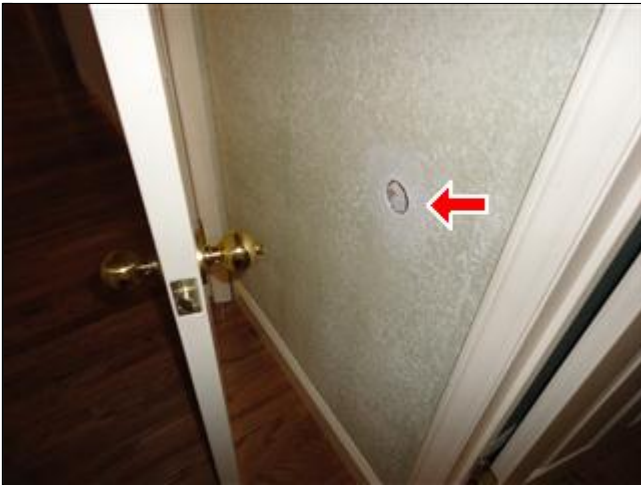
5.1 Item 2(Picture)

**5.1 (3)** The sheetrock on the wall is dented or damaged from door knob at the hallway. While this damage is cosmetic, it needs to be repaired. A qualified contractor should inspect and repair as needed and install door stop to prevent re-occurrence of damage.

- 🔧 (3) The sheetrock on the wall is dented or damaged from door knob at the hallway. While this damage is cosmetic, it needs to be repaired. A qualified contractor should inspect and repair as needed and install door stop to prevent re-occurrence of damage.

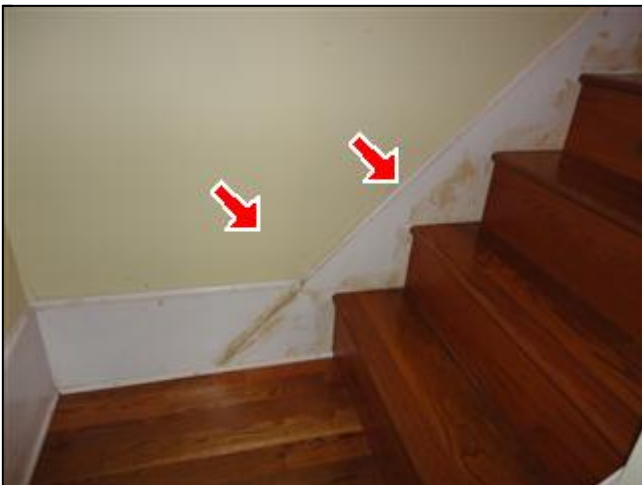
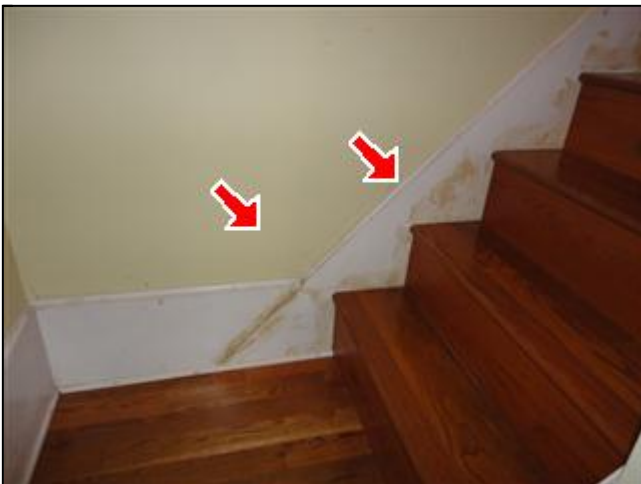
5.1 Item 3(Picture)

**5.1 (4)** Stair cover trim is unfinished, this should be prepped and painted at stairs.

- 🔧 (4) Stair cover trim is unfinished, this should be prepped and painted at stairs.

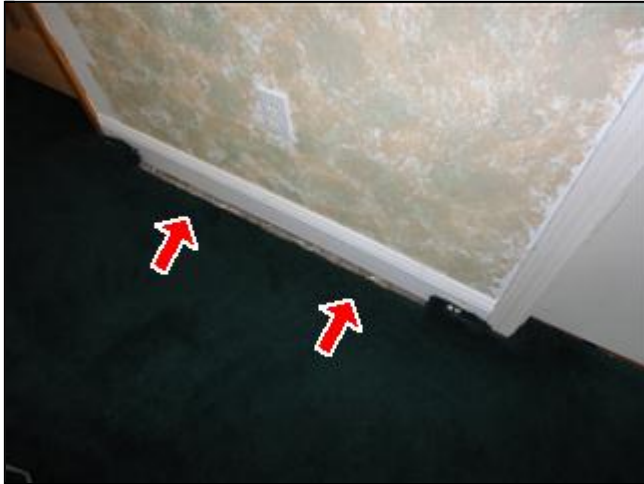
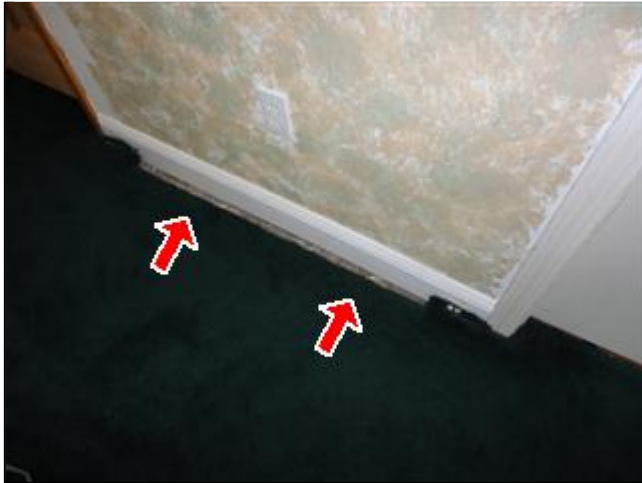
5.2 Item 1(Picture)

**5.2** Carpet is loose or cut short from where electric baseboard use to be in areas around the perimeter of the Den.

- Carpet is loose or cut short from where electric baseboard use to be in areas around the perimeter of the Den.

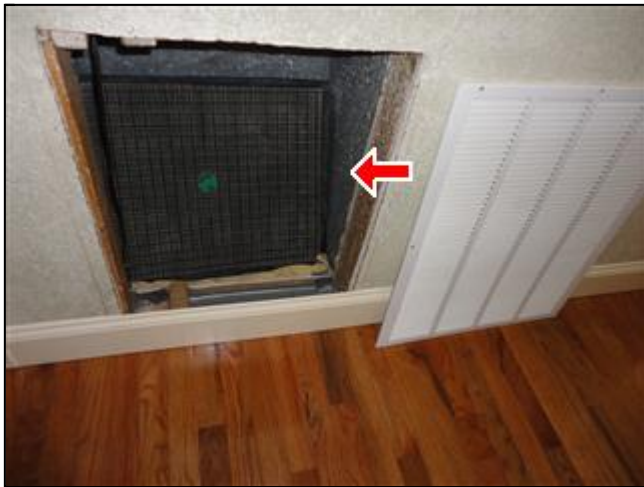
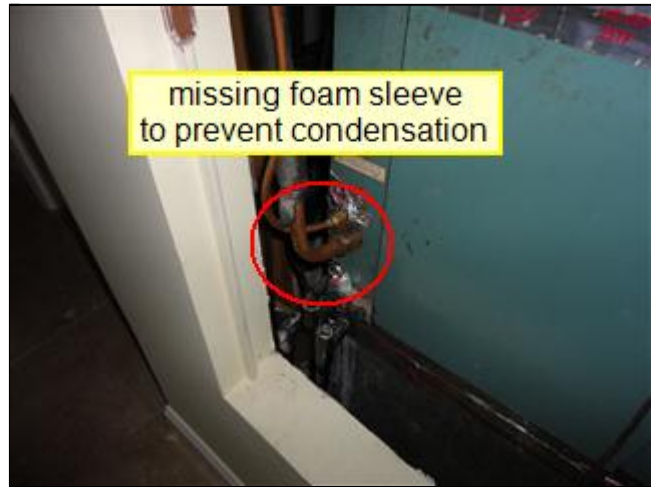
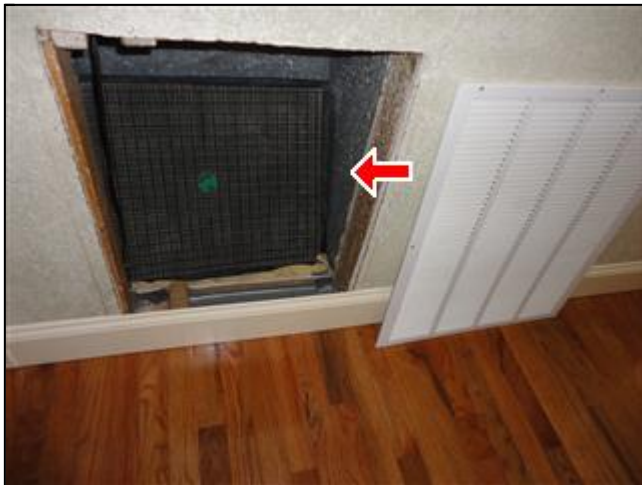
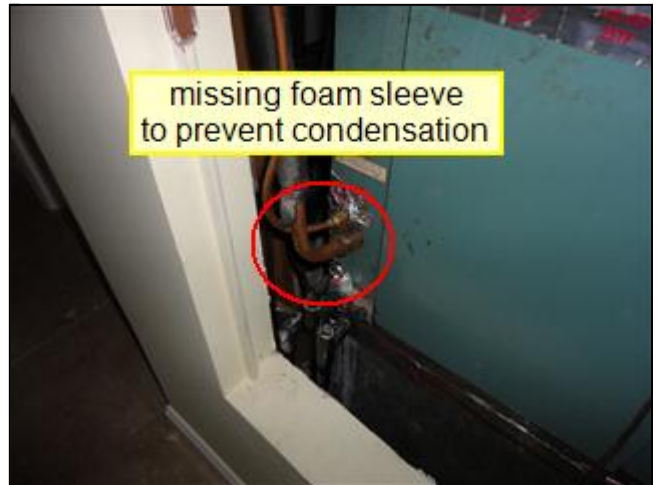
10.3 Item 1(Picture)

**10.3** The washable filter is dirty. The filter needs to be cleaned. Recommend foil taping the filter for a better seal. Foam sleeve missing at suction line creates condensation and drips water.

- The washable filter is dirty. The filter needs to be cleaned. Recommend foil taping the filter for a better seal. Foam sleeve missing at suction line creates condensation and drips water.

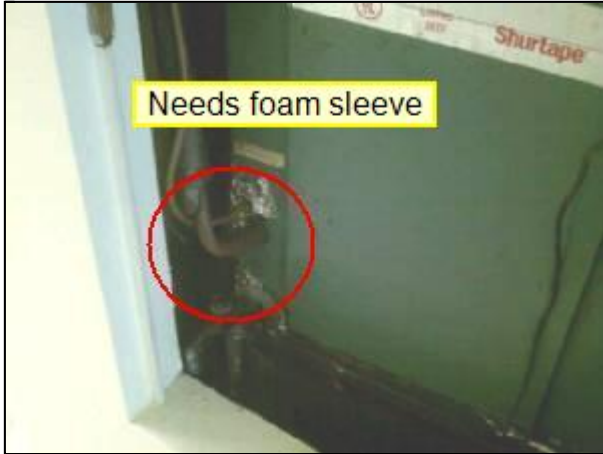
10.8 Item 1(Picture)

**10.8** Air handler and heat pump is old but appears to be working properly. Foam sleeve on suction line is not covering copper line and condensation can drip.
